# MAORI FORTIFICATIONS OF THE OMATA AND OAKURA DISTRICTS, TARANAKI

NIGEL PRICKETT

AUCKLAND INSTITUTE AND MUSEUM

*Abstract.* Thirty-two Maori fortifications of the Omata and Oakura districts, Taranaki, are described. The majority of sites have ring-ditch defences. A high proportion enclose only a very small occupation area.

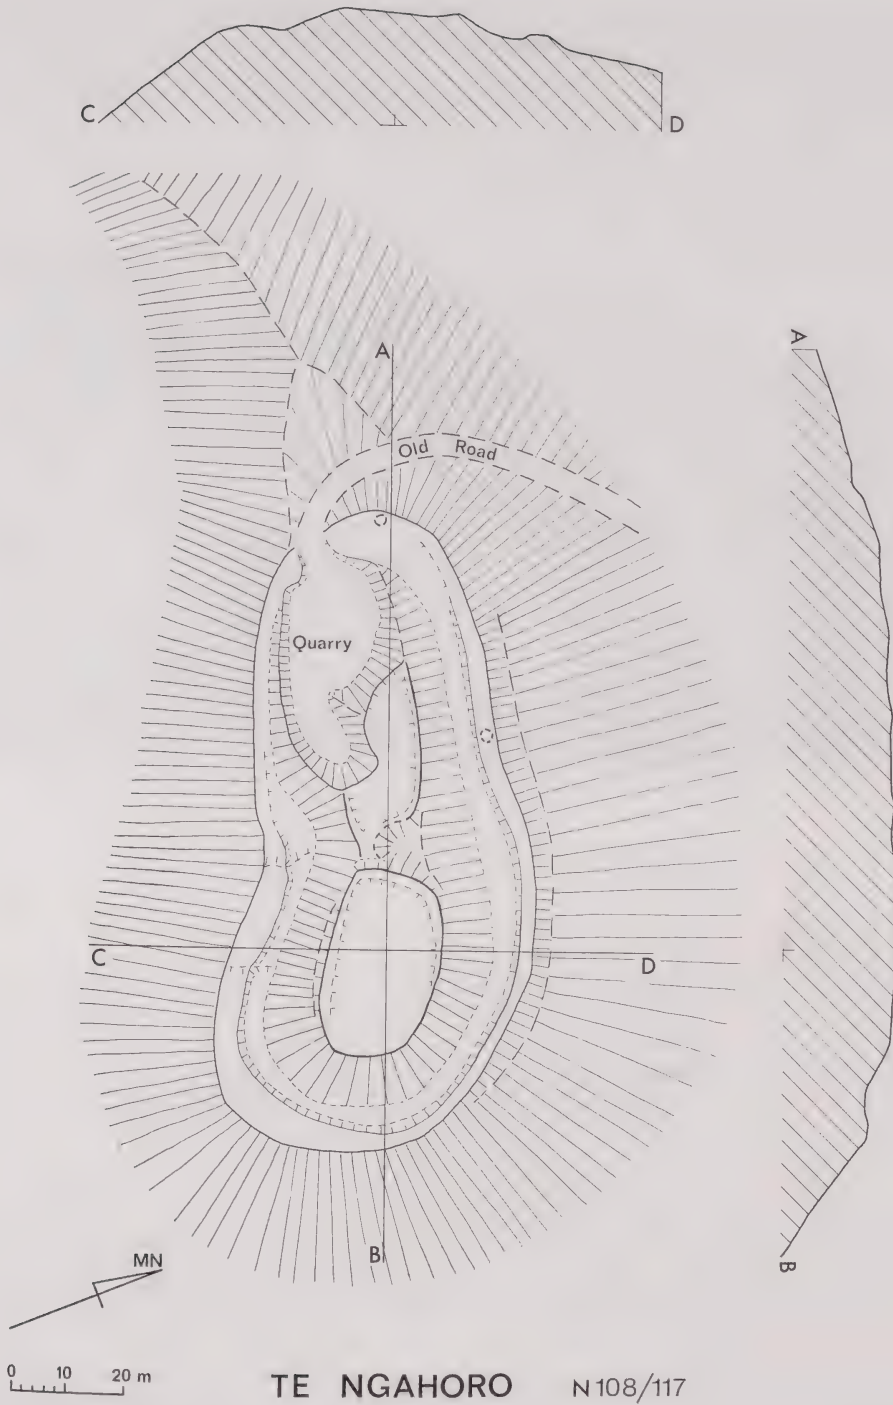
Fig. 2. Plan and sections of Te Ngahoro (N108/117).  
(For key to plan figures see below Fig. 1).

## Te Ngahoro N108/117 (598888) Figs. 2, 3

Defences consist of a single ditch and bank which runs around the site, broken only by road access to the old quarry. Outside the artificial defences further security is given by the steep slope of the hill to the south and east. A slight spur runs down to the west, while to the north there is an easy slope to the level ground below. The scarp from the bottom of the ditch to the rim of the occupation platforms is now about 4 m in height. Within the pa there are two platforms separated by a slight ditch and scarps which presumably indicate additional, internal defence. A slight rim surrounds most of what remains of the circumference of the two platforms.

Of the two platforms, the intact eastern one is the larger, being *ca.* 575 m<sup>2</sup> in area. It is also the higher platform of the two. The lower platform appears to have been *ca.* 450 m<sup>2</sup>. The total occupation area including the internal defences is *ca.* 1100 m<sup>2</sup>. There is no surface evidence of house terraces or other features on the two platforms. Two slight depressions in the outer bank are suggestive of collapsed *rua*, or underground food storage pits.

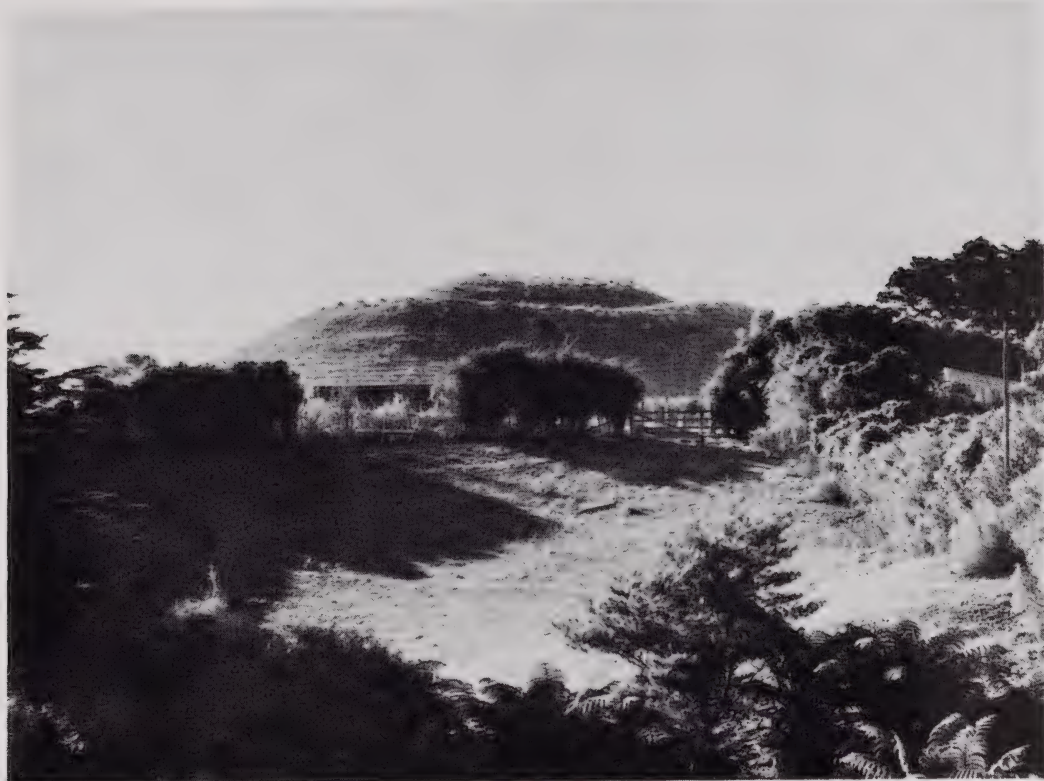
Fig. 3. Te Ngahoro from South Road — view from the east.

Te Ngahoro is situated on a prominent hill rising above the surrounding terrace country seaward of the main South Road between Beach Road and Herekawe Stream. It thus commands a wide area northwards to Paritutu and south to Waireka Stream. The site is topped by the 'Lloyd G' trig station, 88.5 m above sea level. Damage has been done by quarrying operations which some time in the past saw the removal of much of one of the two occupation platforms of the pa. The site is now under pasture. Its prominent skyline situation and its location on the outskirts of New Plymouth make Te Ngahoro one of the most visually important archaeological sites in Taranaki.

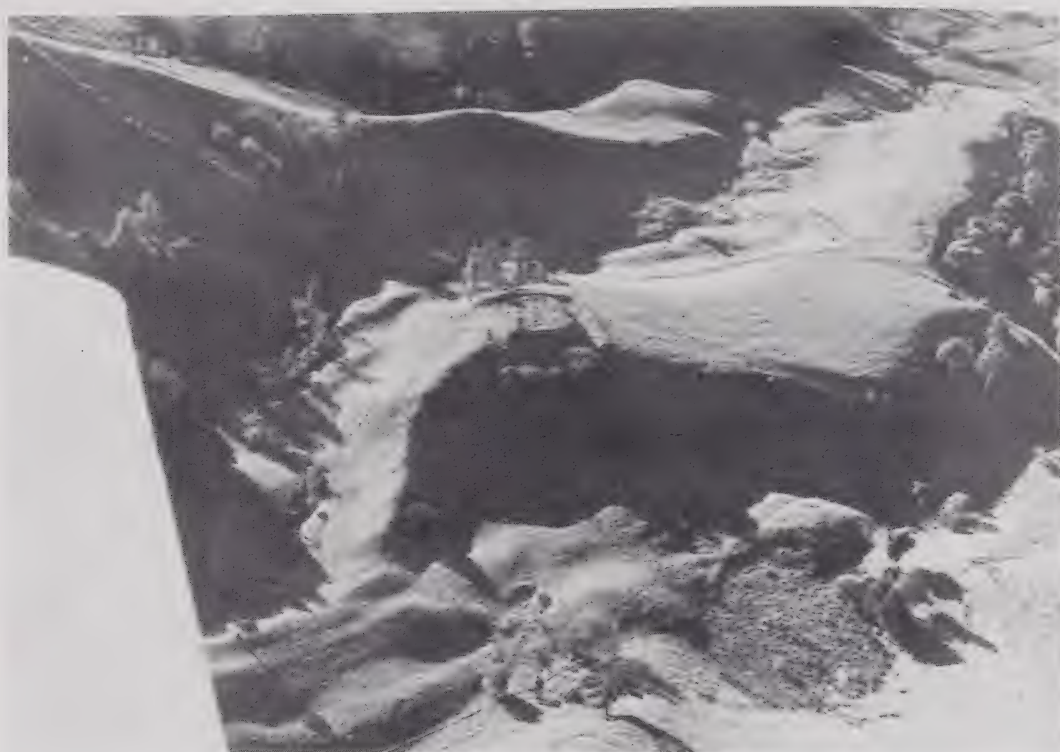
Fig. 5. Potikitaua — aerial view from the south.

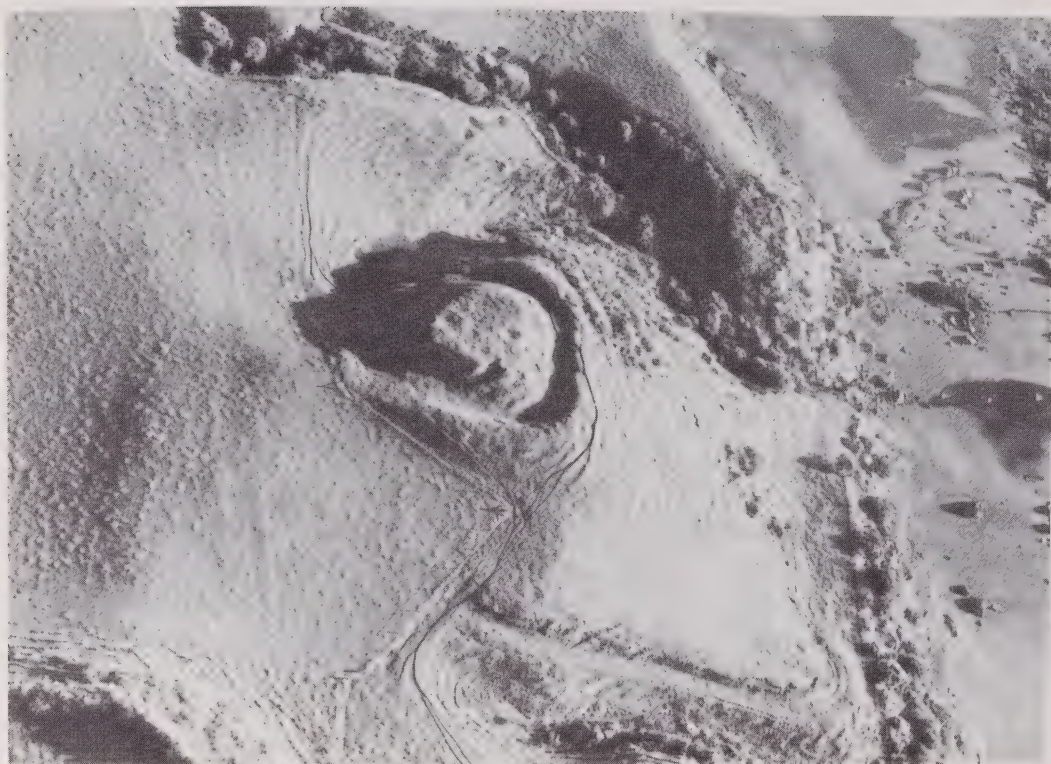
Fig. 13. Omuna (N108/18) — aerial view from the north.

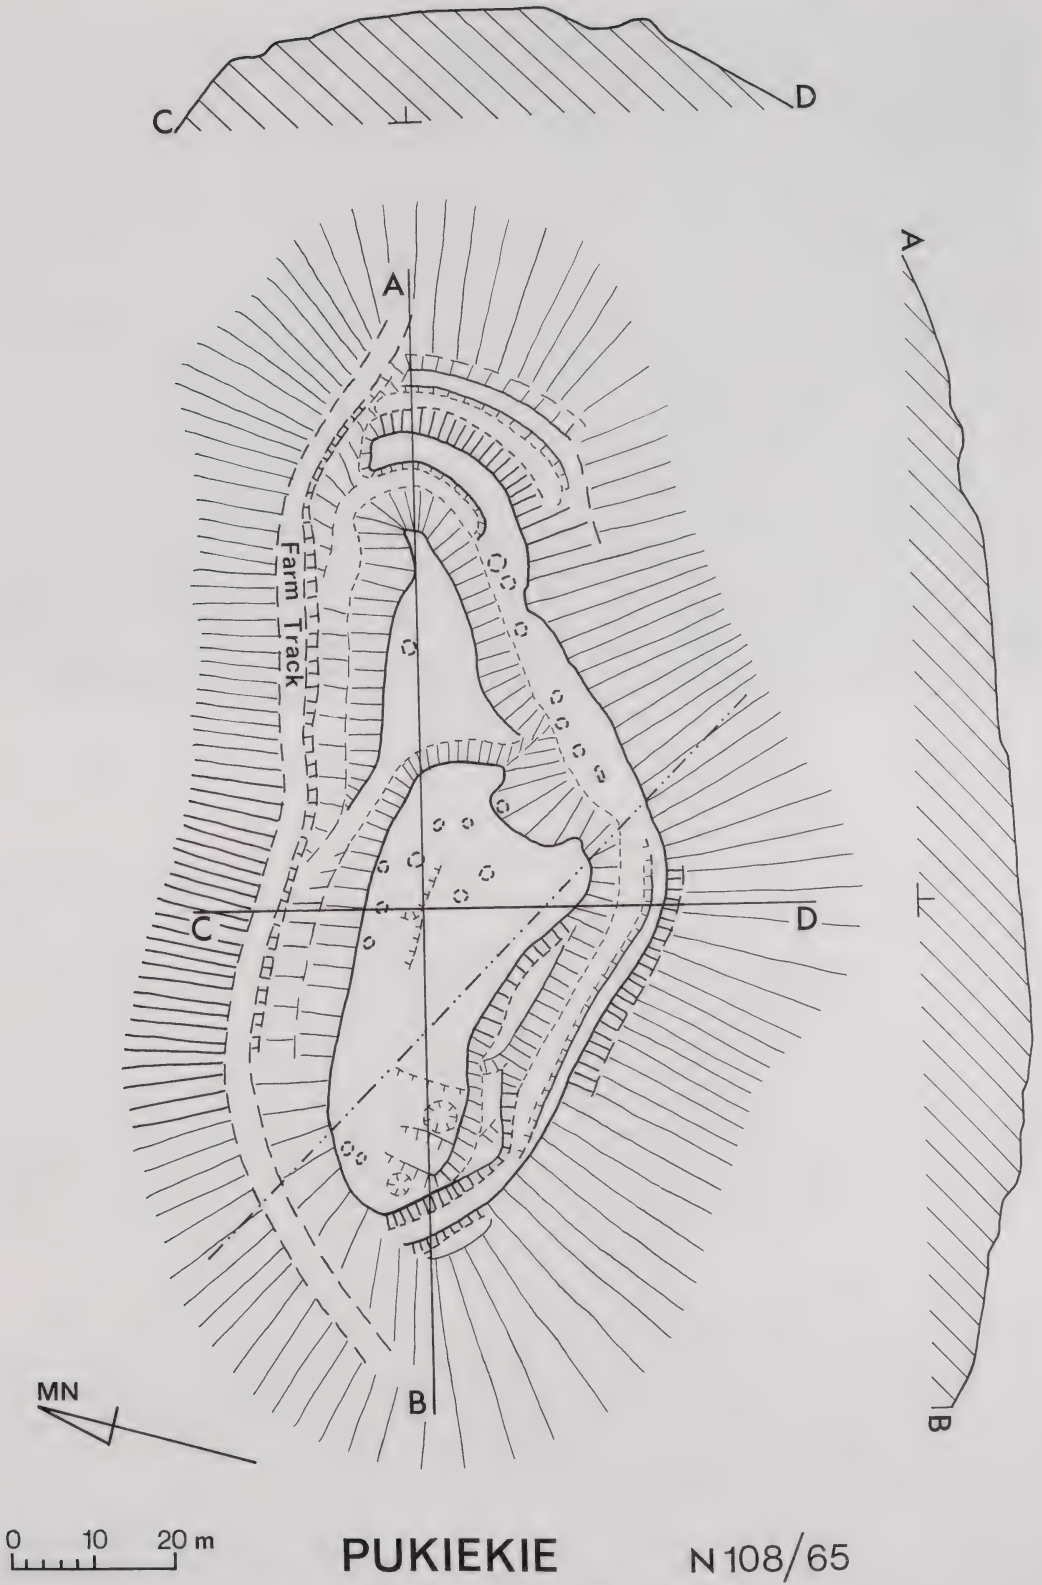
Fig. 16. Plan and sections of Pukiekie (N108/65).

situations were available remains the unobtrusive spur end low in the stream valleys. Pukiekie is protected to the north, west and south by precipitous natural slopes to the now swampy valley bottoms *ca.* 40-50 m below the defences. To the east is a slight saddle to extensive, slightly lower, rolling country. Artificial defence is made up of a single ditch and bank which was presumably continuous around the site. At the vulnerable east end is a short length of double ditch and bank. A scarp of 1.5 m divides the occupation area in two and may have provided a basis for further internal defences directed at holding the major platform in the face of possession of the lower east end of the pa by an attacking party.

The uneven larger occupation platform has upwards of ten *rua* and several small terraces which together indicate something of the internal organisation. The *rua* cluster at the two ends of the platform. A further six or seven *rua* are located in the defensive ditch of the south-east side of the pa. The lower platform is triangular in plan. Only one *rua* could be located on it. The maximum dimensions of the occupation area within the defences are 80 x 25 m with an area of *ca.* 1350 m<sup>2</sup>. The upper platform is *ca.* 1000 m<sup>2</sup> and the lower *ca.* 300 m<sup>2</sup>. Immediately outside the defences at the west end of the site is a single terrace 8 x 2 m in size, while three more terraces are further down the steep western spur, *ca.* 20 m below the defences.

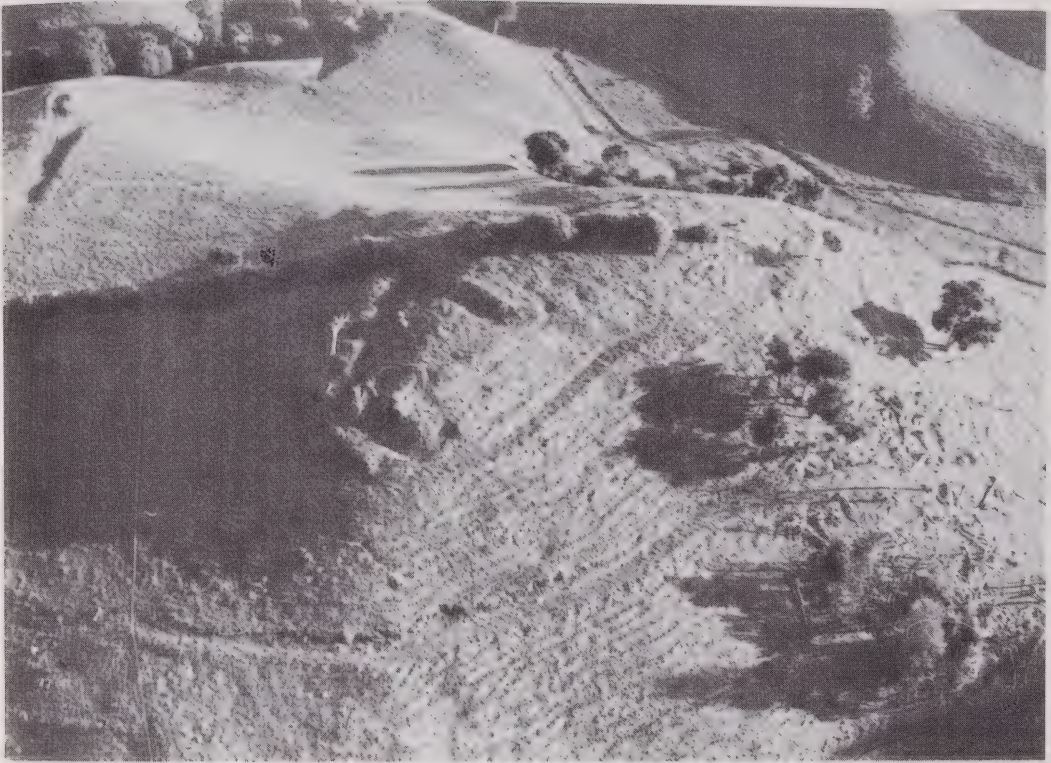
Fig. 17. Pukiekie — aerial view from the north-east.

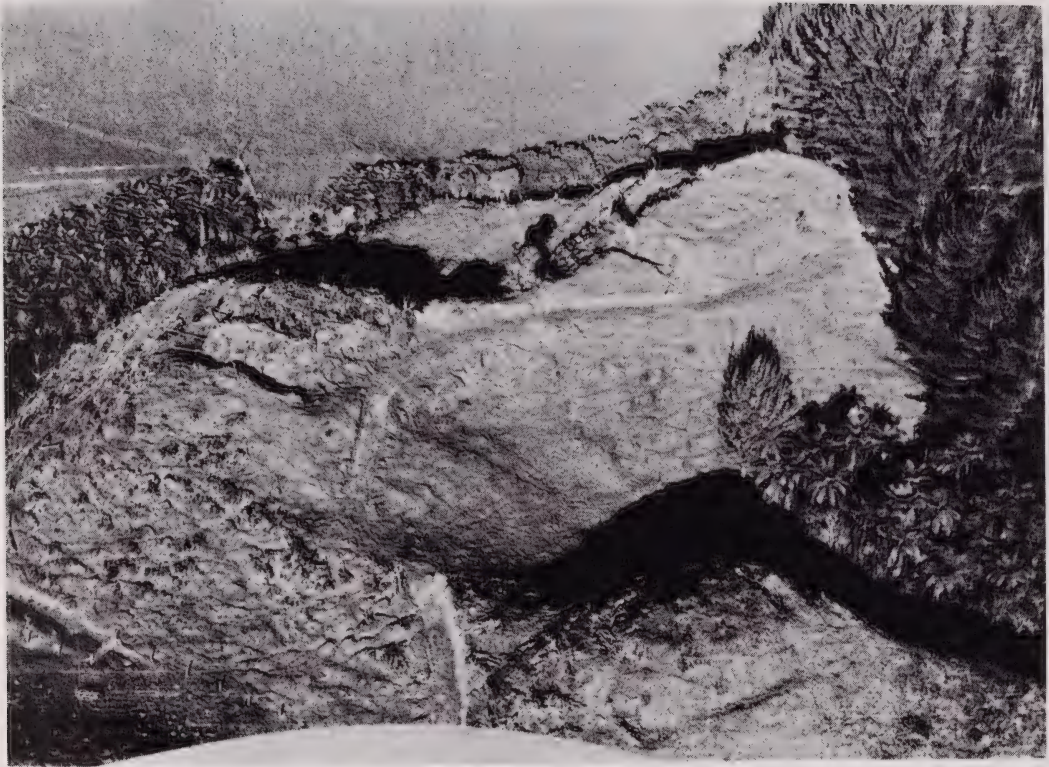
Fig. 19. N108/29 — aerial view from the south-west.

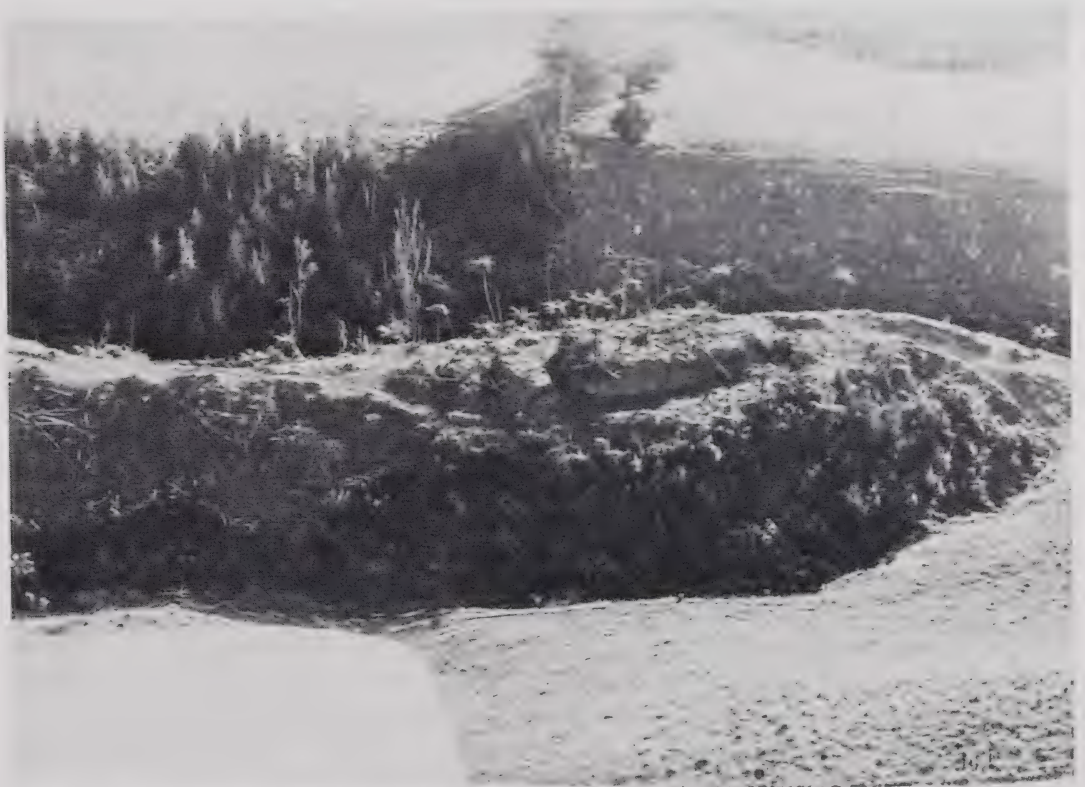
Fig. 20. Areromaoa — aerial view from the north. Taken in November 1974, the photograph shows the remains of three defensive ditches east (left) of the occupation platform which have since been destroyed.

## Areromaoa N108/30 (571838) Figs. 20, 21

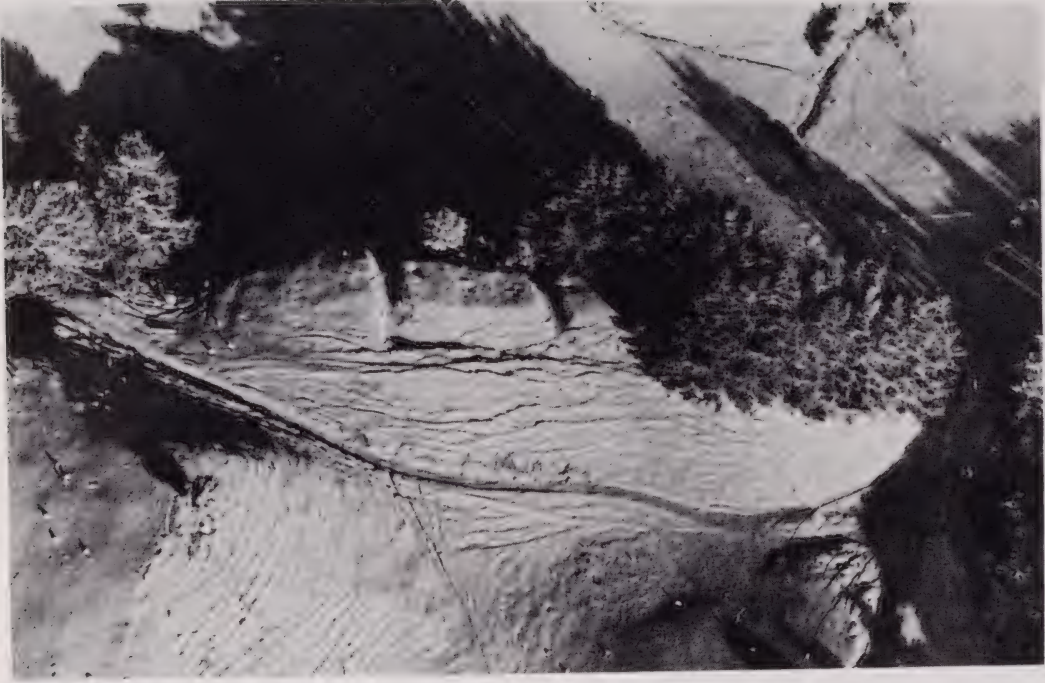
Fig. 23. Te Awahahae — aerial view from the north-west.

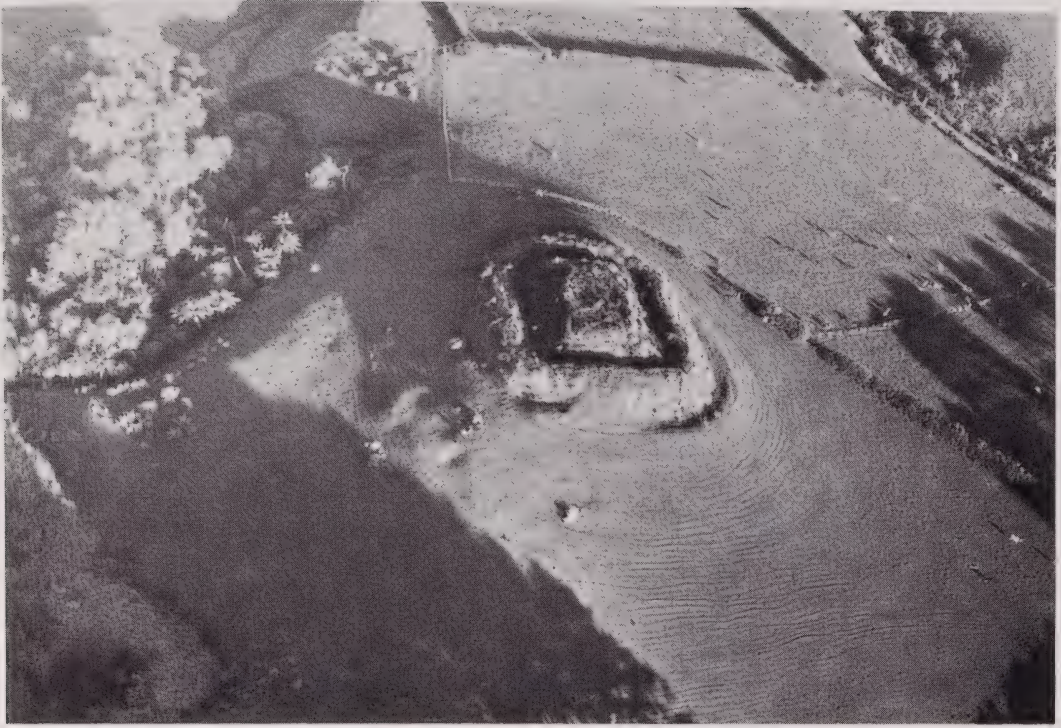
Fig. 26. Pahitere (N108/24) — aerial view from the north. Wahawakiore is under bush cover at top left.

#### Pahitere N108/24 (553852) Fig. 26

Pahitere was occupied in 1864 by part of a company of Taranaki Military Settlers and was modified to an unknown extent to accommodate the troops. This occupation has resulted in the very rectangular plan of the top platform and the outer defences as they now appear, in the terraces on the eastern side of the hill and in the slight bank which

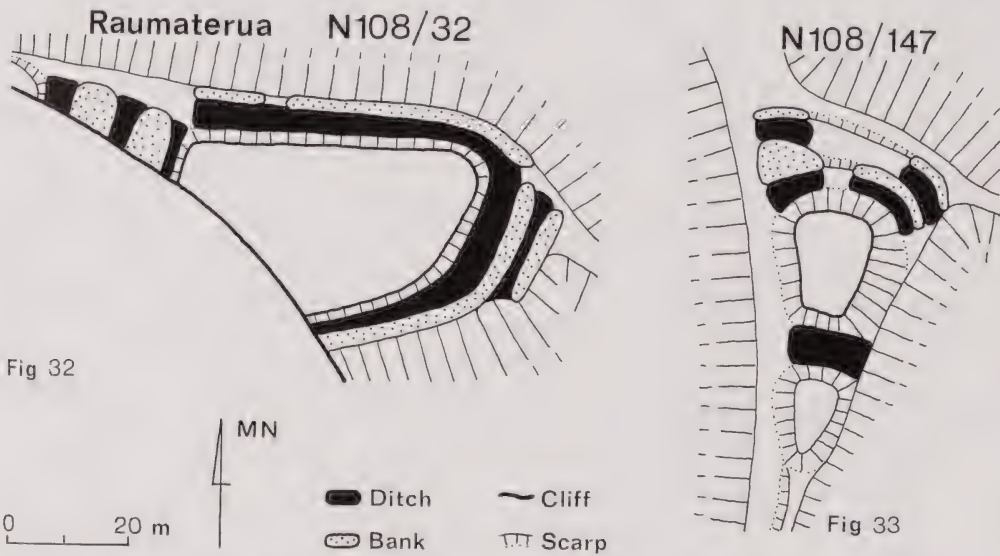
Figs. 32, 33. Pa plans. 32. Raumaterua (N108/32). 33. N108/147.

The pa is strongly situated on a steep sided spur which runs down to the south-east from the extensive terrace of the Koru Road district. The west side is secured by a 12 m cliff to the river while the north side drops precipitously *ca.* 9 m into a now swampy gully.

The occupation platform is *ca.* 45 m long and 6-26 m broad. The area is *ca.* 700 m<sup>2</sup>. Dense gorse ruled out a thorough examination and only one *rua* was found at the platform's eastern corner.
